TS-AMD-83056e
November 1984

AERIAL PHOTOGRAPHIC ANALYSIS OF WASTE STUDY SITES

Montana

AERIAL PHOTOGRAPHIC ANALYSIS
WASTE STUDY SITES

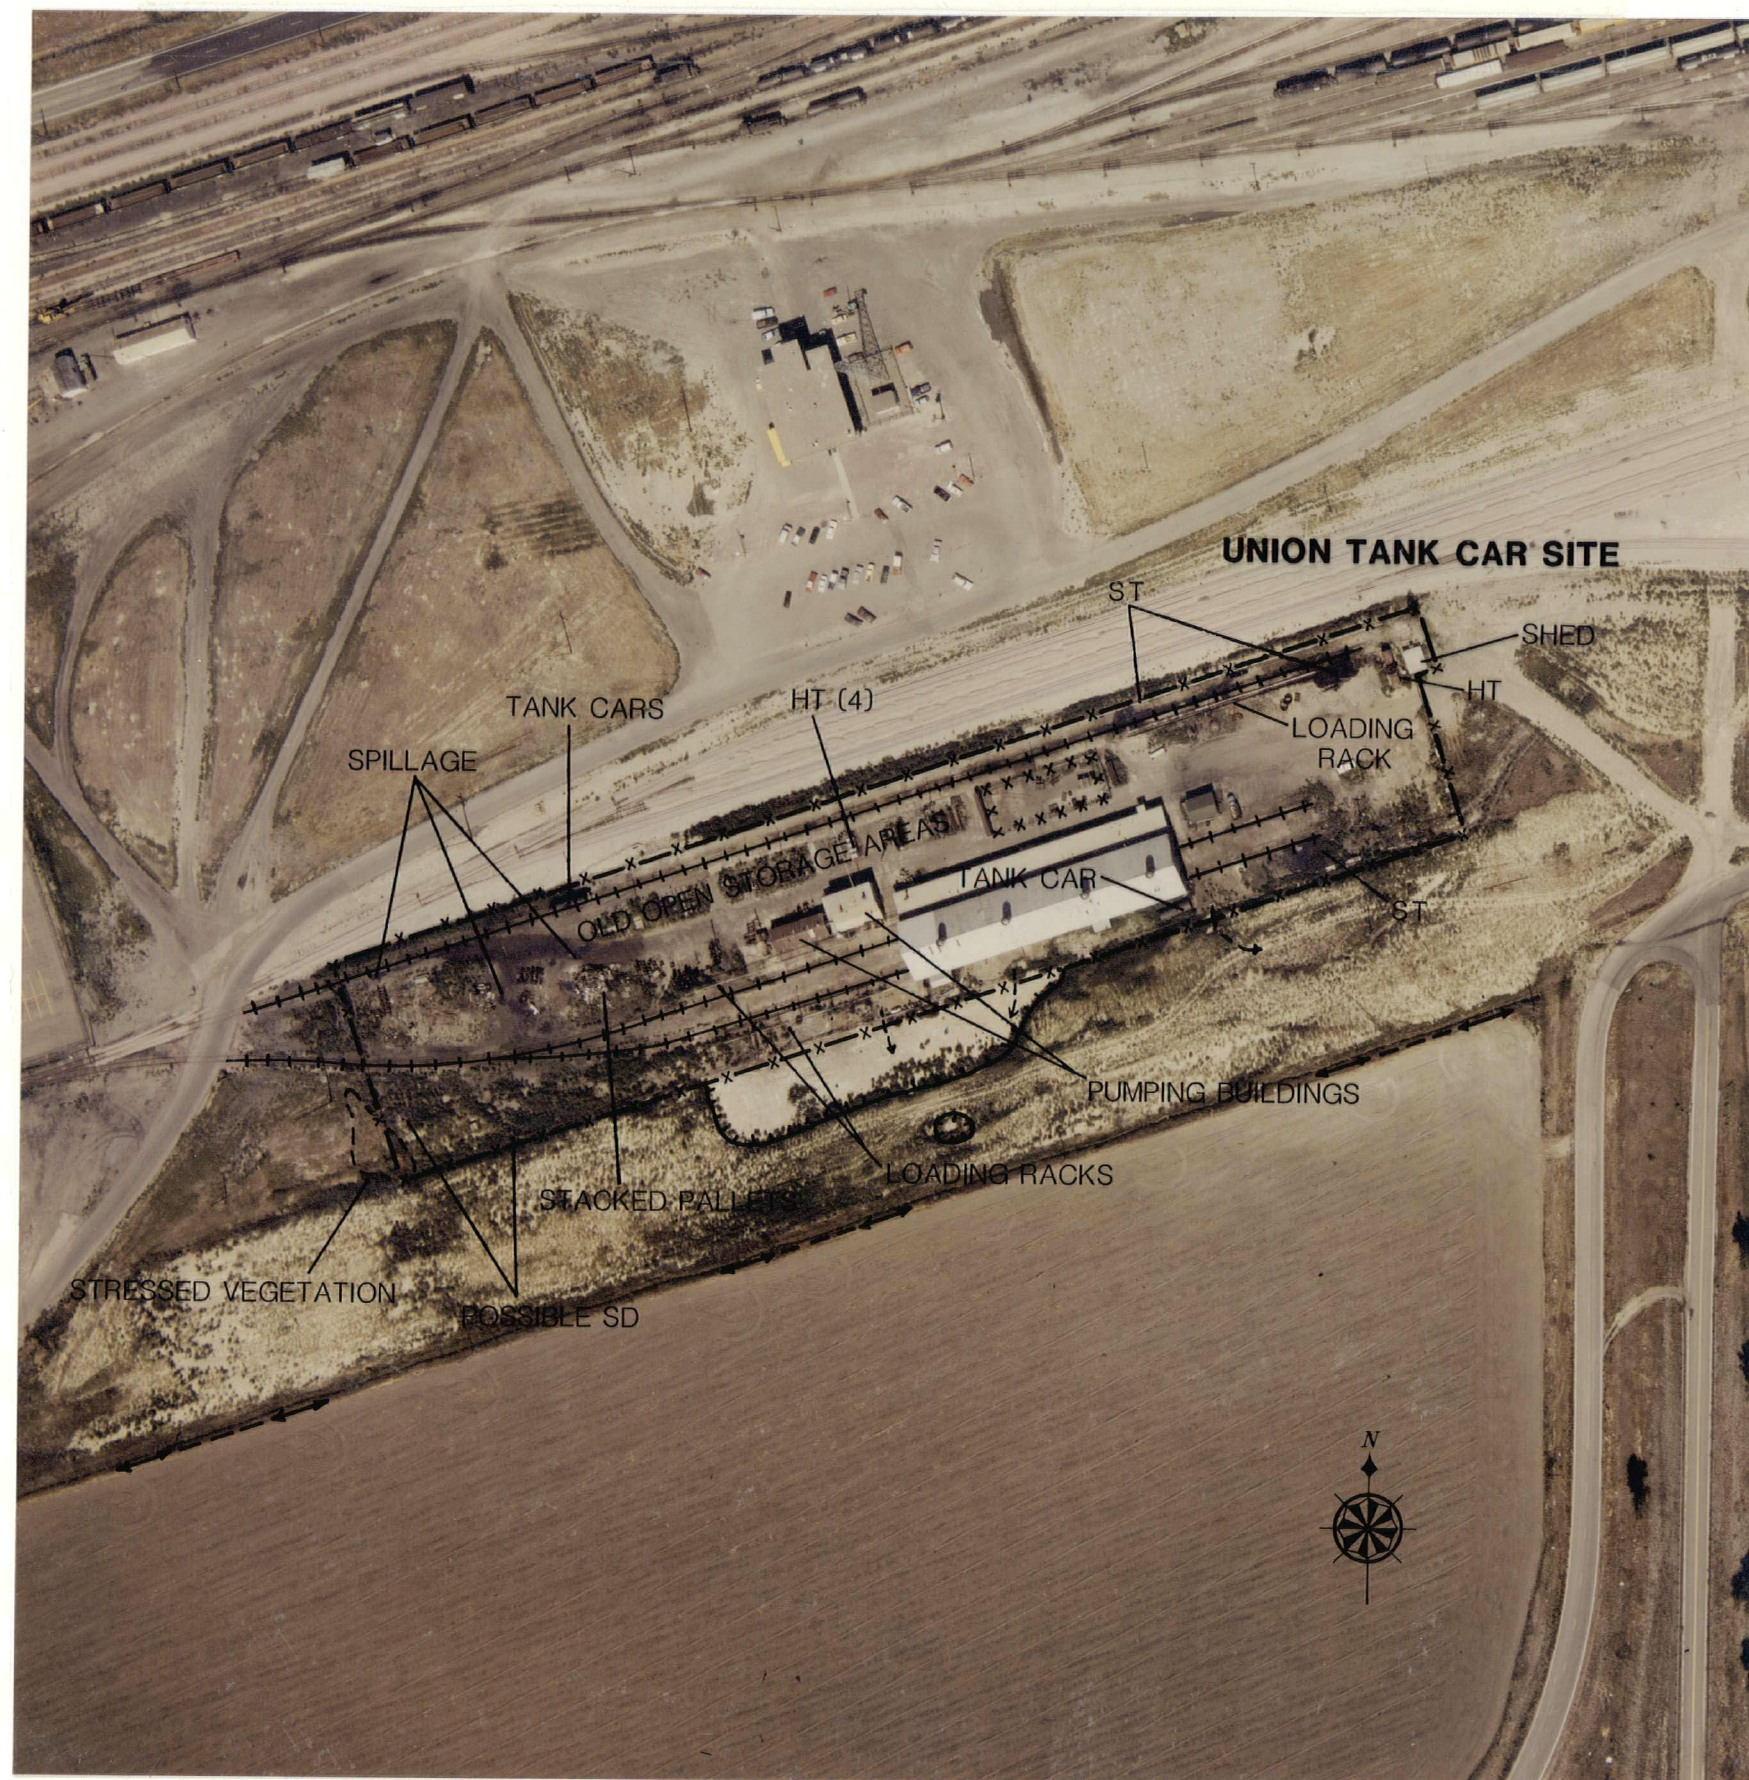
Figure 13. Union Tank Car site, August 27, 1983. Approximate scale 1:2,050.

Spillage is visible at three points on the southwestern side of the site. Heavy staining is present in this area and at three other locations within the site. Two of these stains are associated with loading racks in the northeast corner of the site.

Two small deposits of a dark sludge-like material are located in the southwest corner of the site. The nature of these deposits is not apparent. An area of stressed vegetation is located on the southwestern edge of the site; however, it does not appear to be related to the deposits. Five horizontal storage tanks are present at the site and two tank cars are also present. An extensive depression and a small pit are located south of the site. Runoff from much of the site would collect in this depression. Drainage at the site is generally from north to south. A security fence surrounds the site at the time of the 1983 photograph. Soil within the site appears to have been contaminated; however, the site does not appear to have had a significant impact on the surrounding environment.

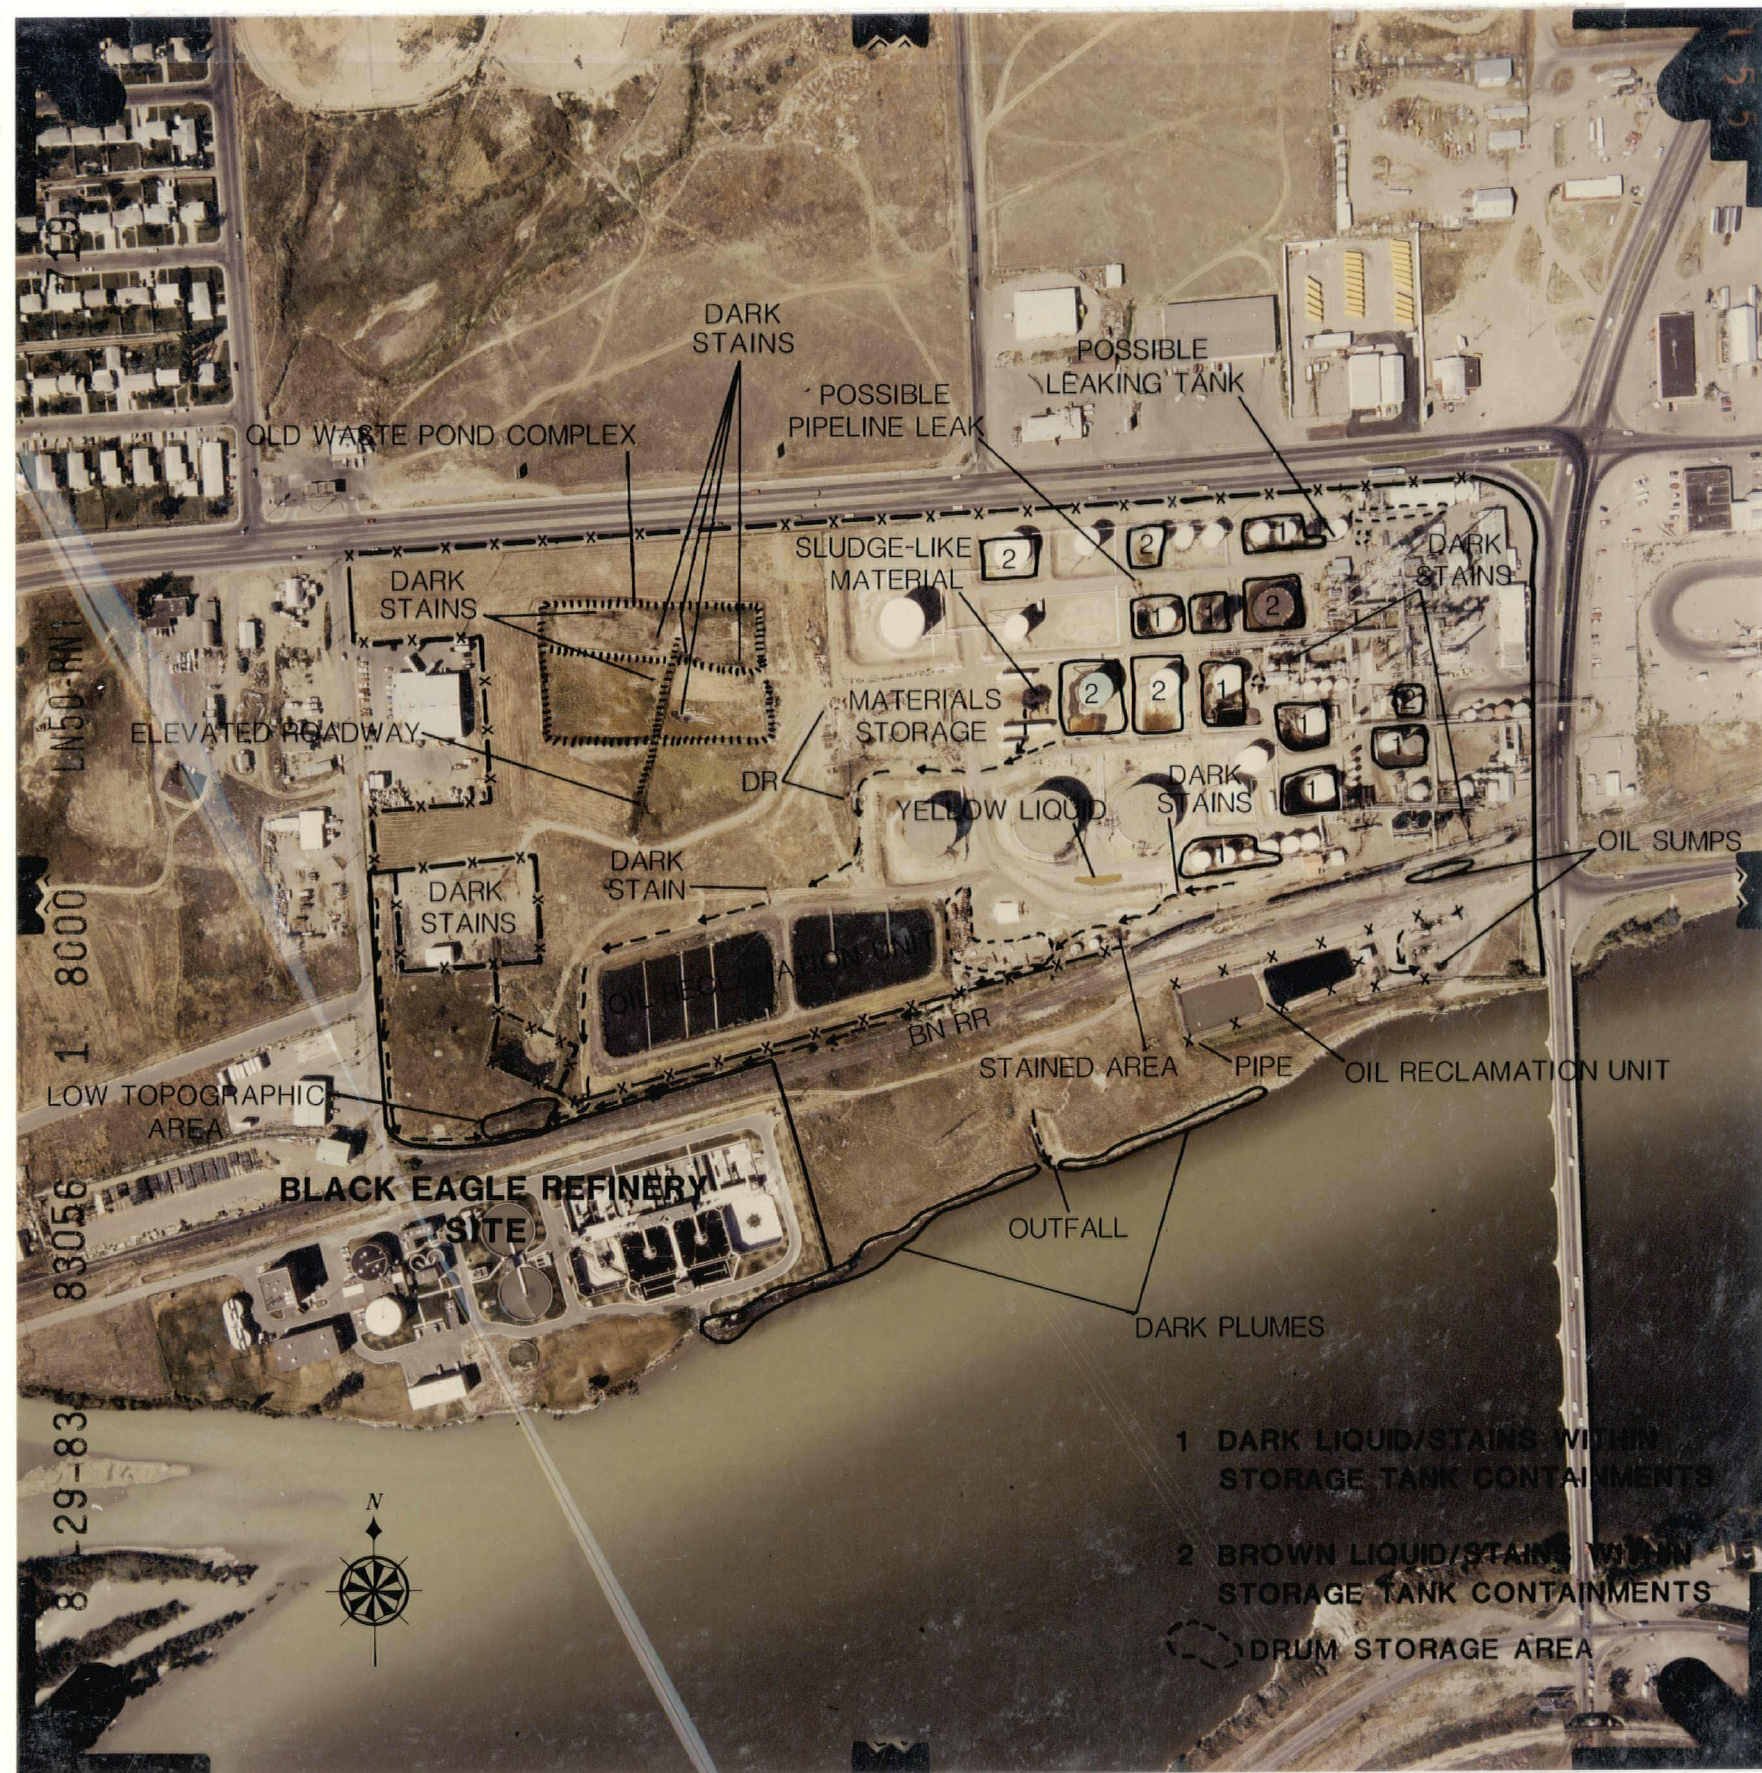
Figure 15. Black Eagle Refinery site, August 29, 1983. Approximate scale 1:8,000.

The Black Eagle Refinery, Figures 14 and 15, is located in Black Eagle, Montana, on the Missouri River. Its approximate size is 24.2 hectares (60 acres). Drainage is generally from the northeast to the southwest. The eastern one-half of the site is the refinery and tank storage area. Poor housekeeping is evident with dark stains scattered throughout this portion of the site. Several storage tank containments hold dark colored and brown liquids. Revetments around all tanks show no evidence of breach or seepage points. A possible leaking tank and pipeline are also present.

West of the tank storage area is an old waste pond complex. Berms are visible at the perimeter of the ponds as well as an apparent elevated roadway. The complex is situated in a slight topographic depression. Six areas having dark stains are present.

At the extreme western end of the refinery is an apparent maintenance yard. Dark stains are visible on the paved surface. Runoff from this area would probably flow south onto a naturally vegetated surface. South of the maintenance yard is a small pond with an access road on the north side. The road appears to have been extended into the pond, perhaps some waste disposal is occurring at this location.

Next to the small pond is an oil reclamation unit. Two ponds are visible. No apparent problems were noted here. An accumulation of drums is present nearby. Drainage from this location flows to the low topographic area in the southwest corner of the site. Two areas of dark stains are visible to the east in the drainageway.

South of the Burlington Northern railroad another apparent oil reclamation unit consisting of two ponds, associated structures and equipment, and an oil sump is visible. Another oil sump is present immediately north of the railroad near the central processing area.

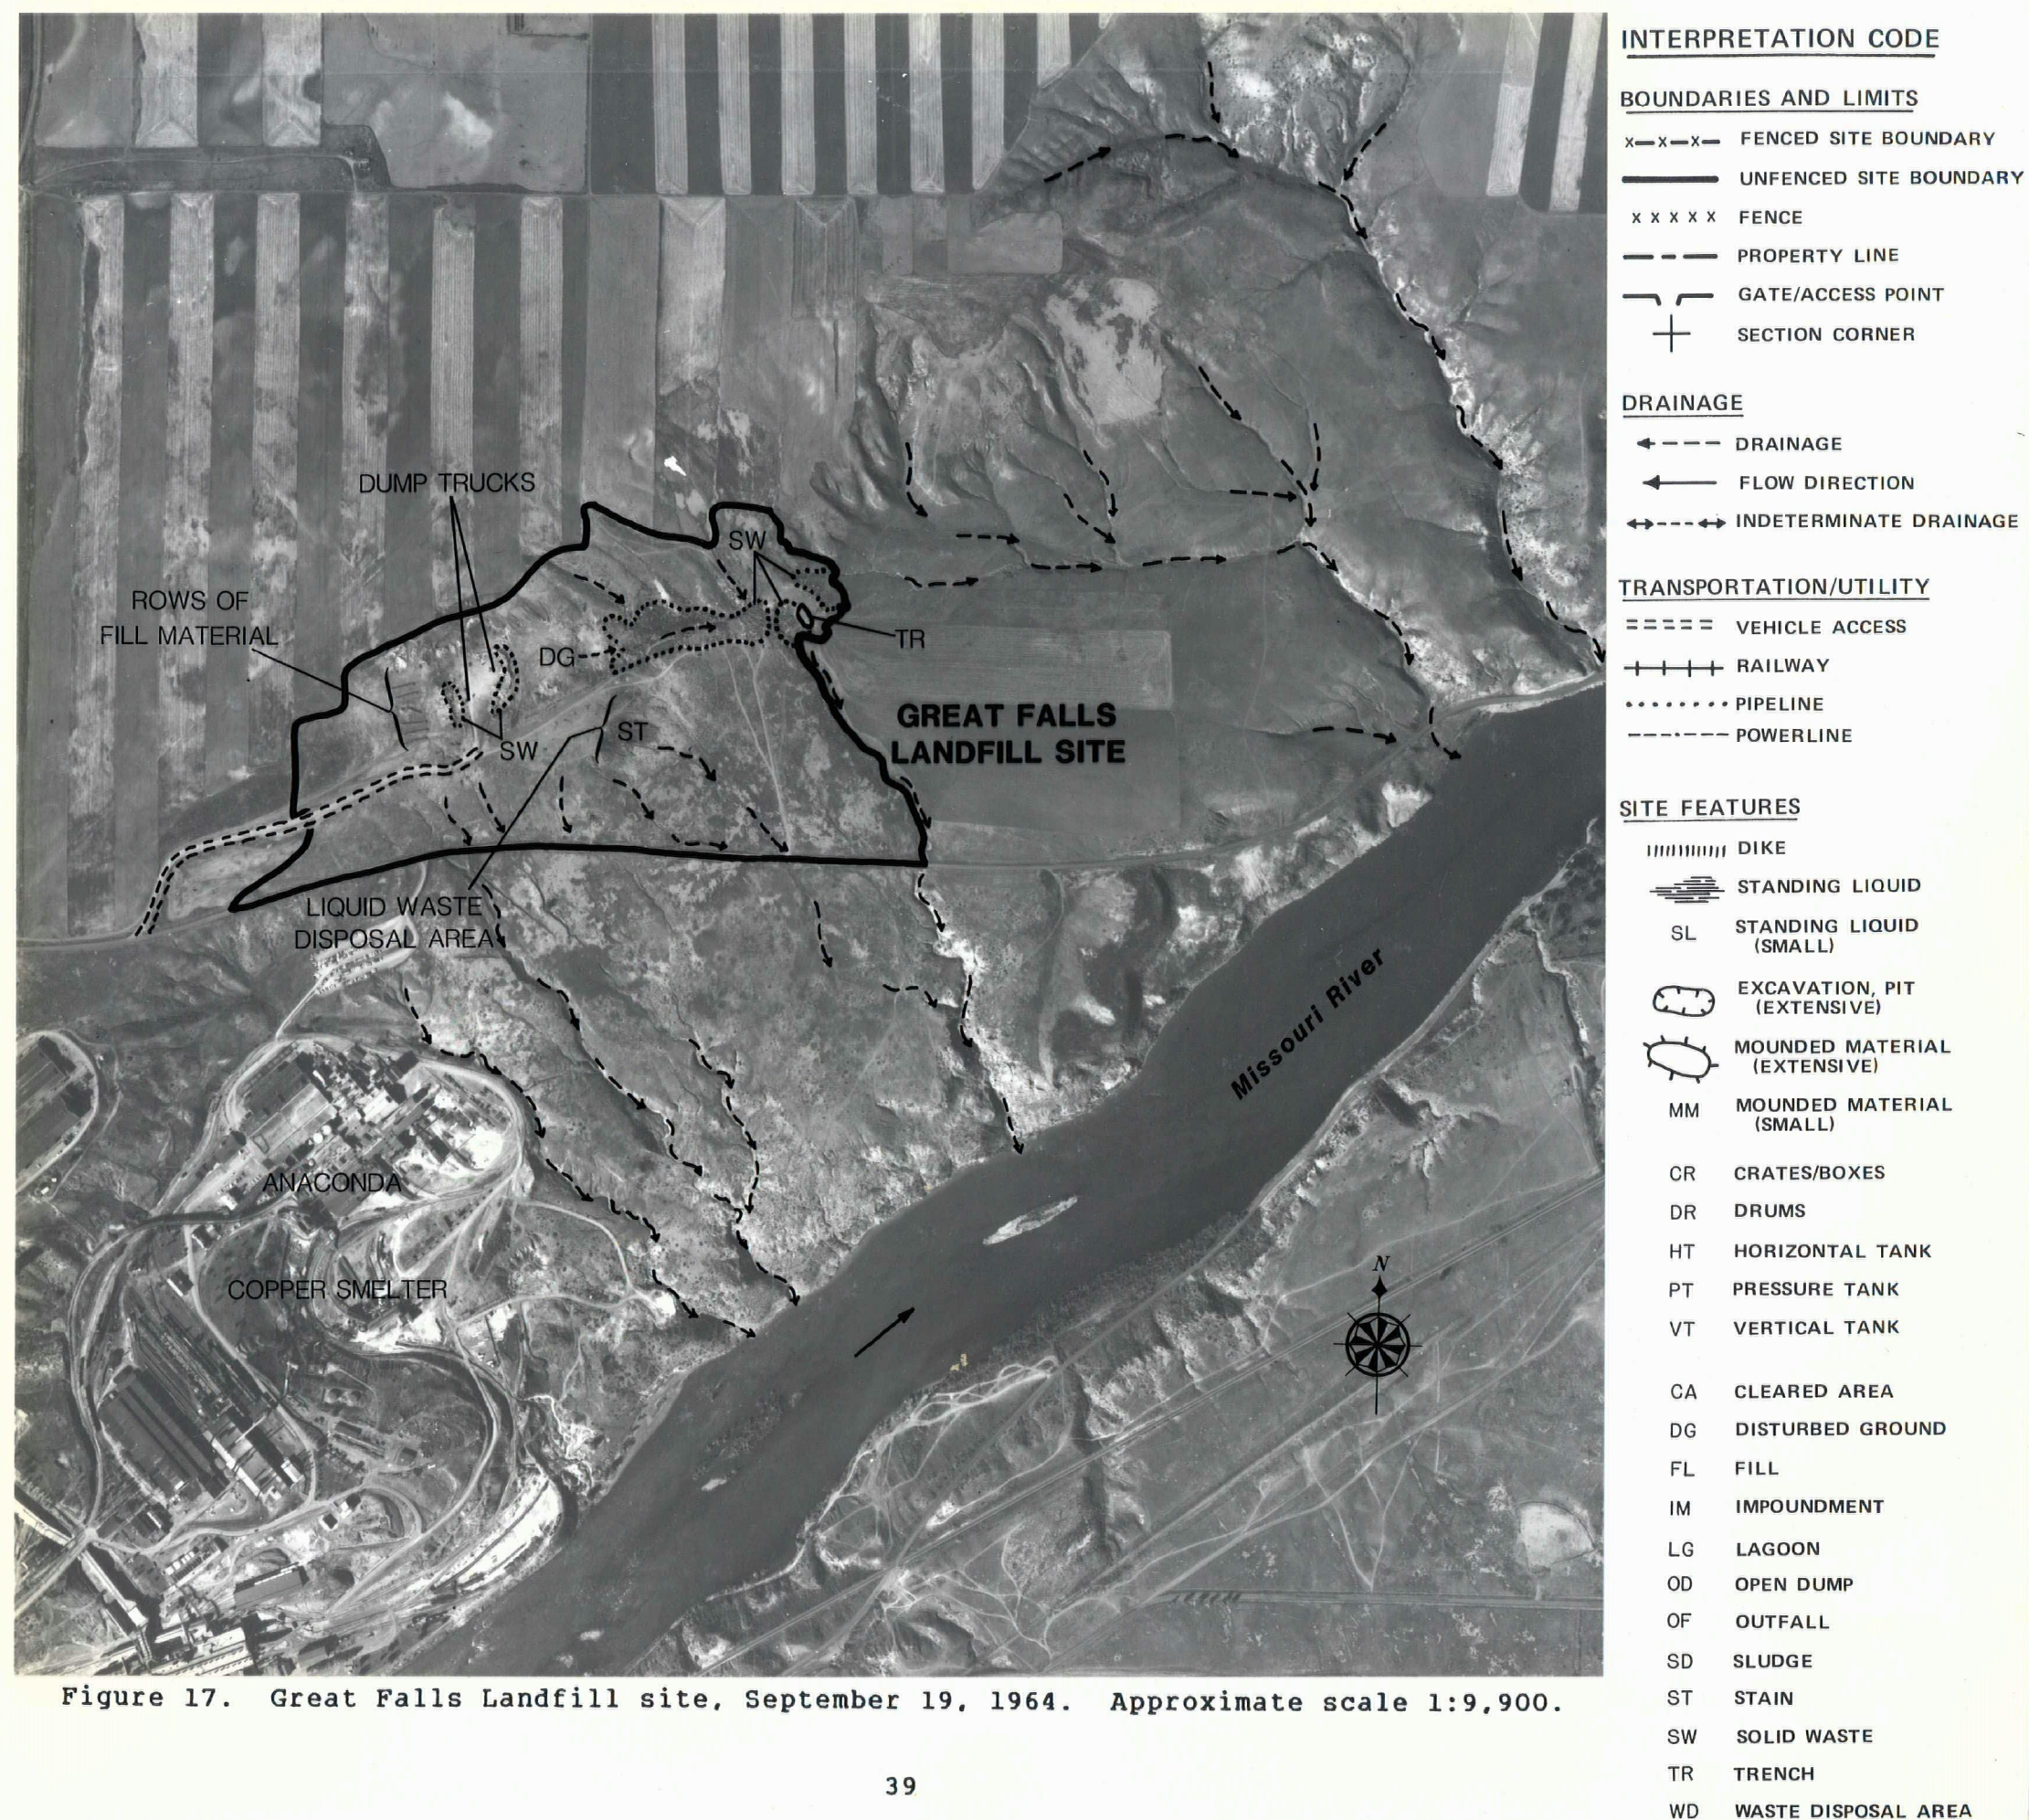
Figure 17 shows that waste disposal activity is underway at the site. Five extensive solid waste deposits are present in the northern section of the site. Most of the waste has been disposed of in the drainage running through the site. A new access road has been constructed into the site from the west. Dump trucks can be seen at several points within the site. Heavy staining is visible at a point near the center of the site. It appears that these stains are the result of liquid waste disposal in this area. Seven rows of fill material are present near the western edge of the site. The nature of this material is not apparent.

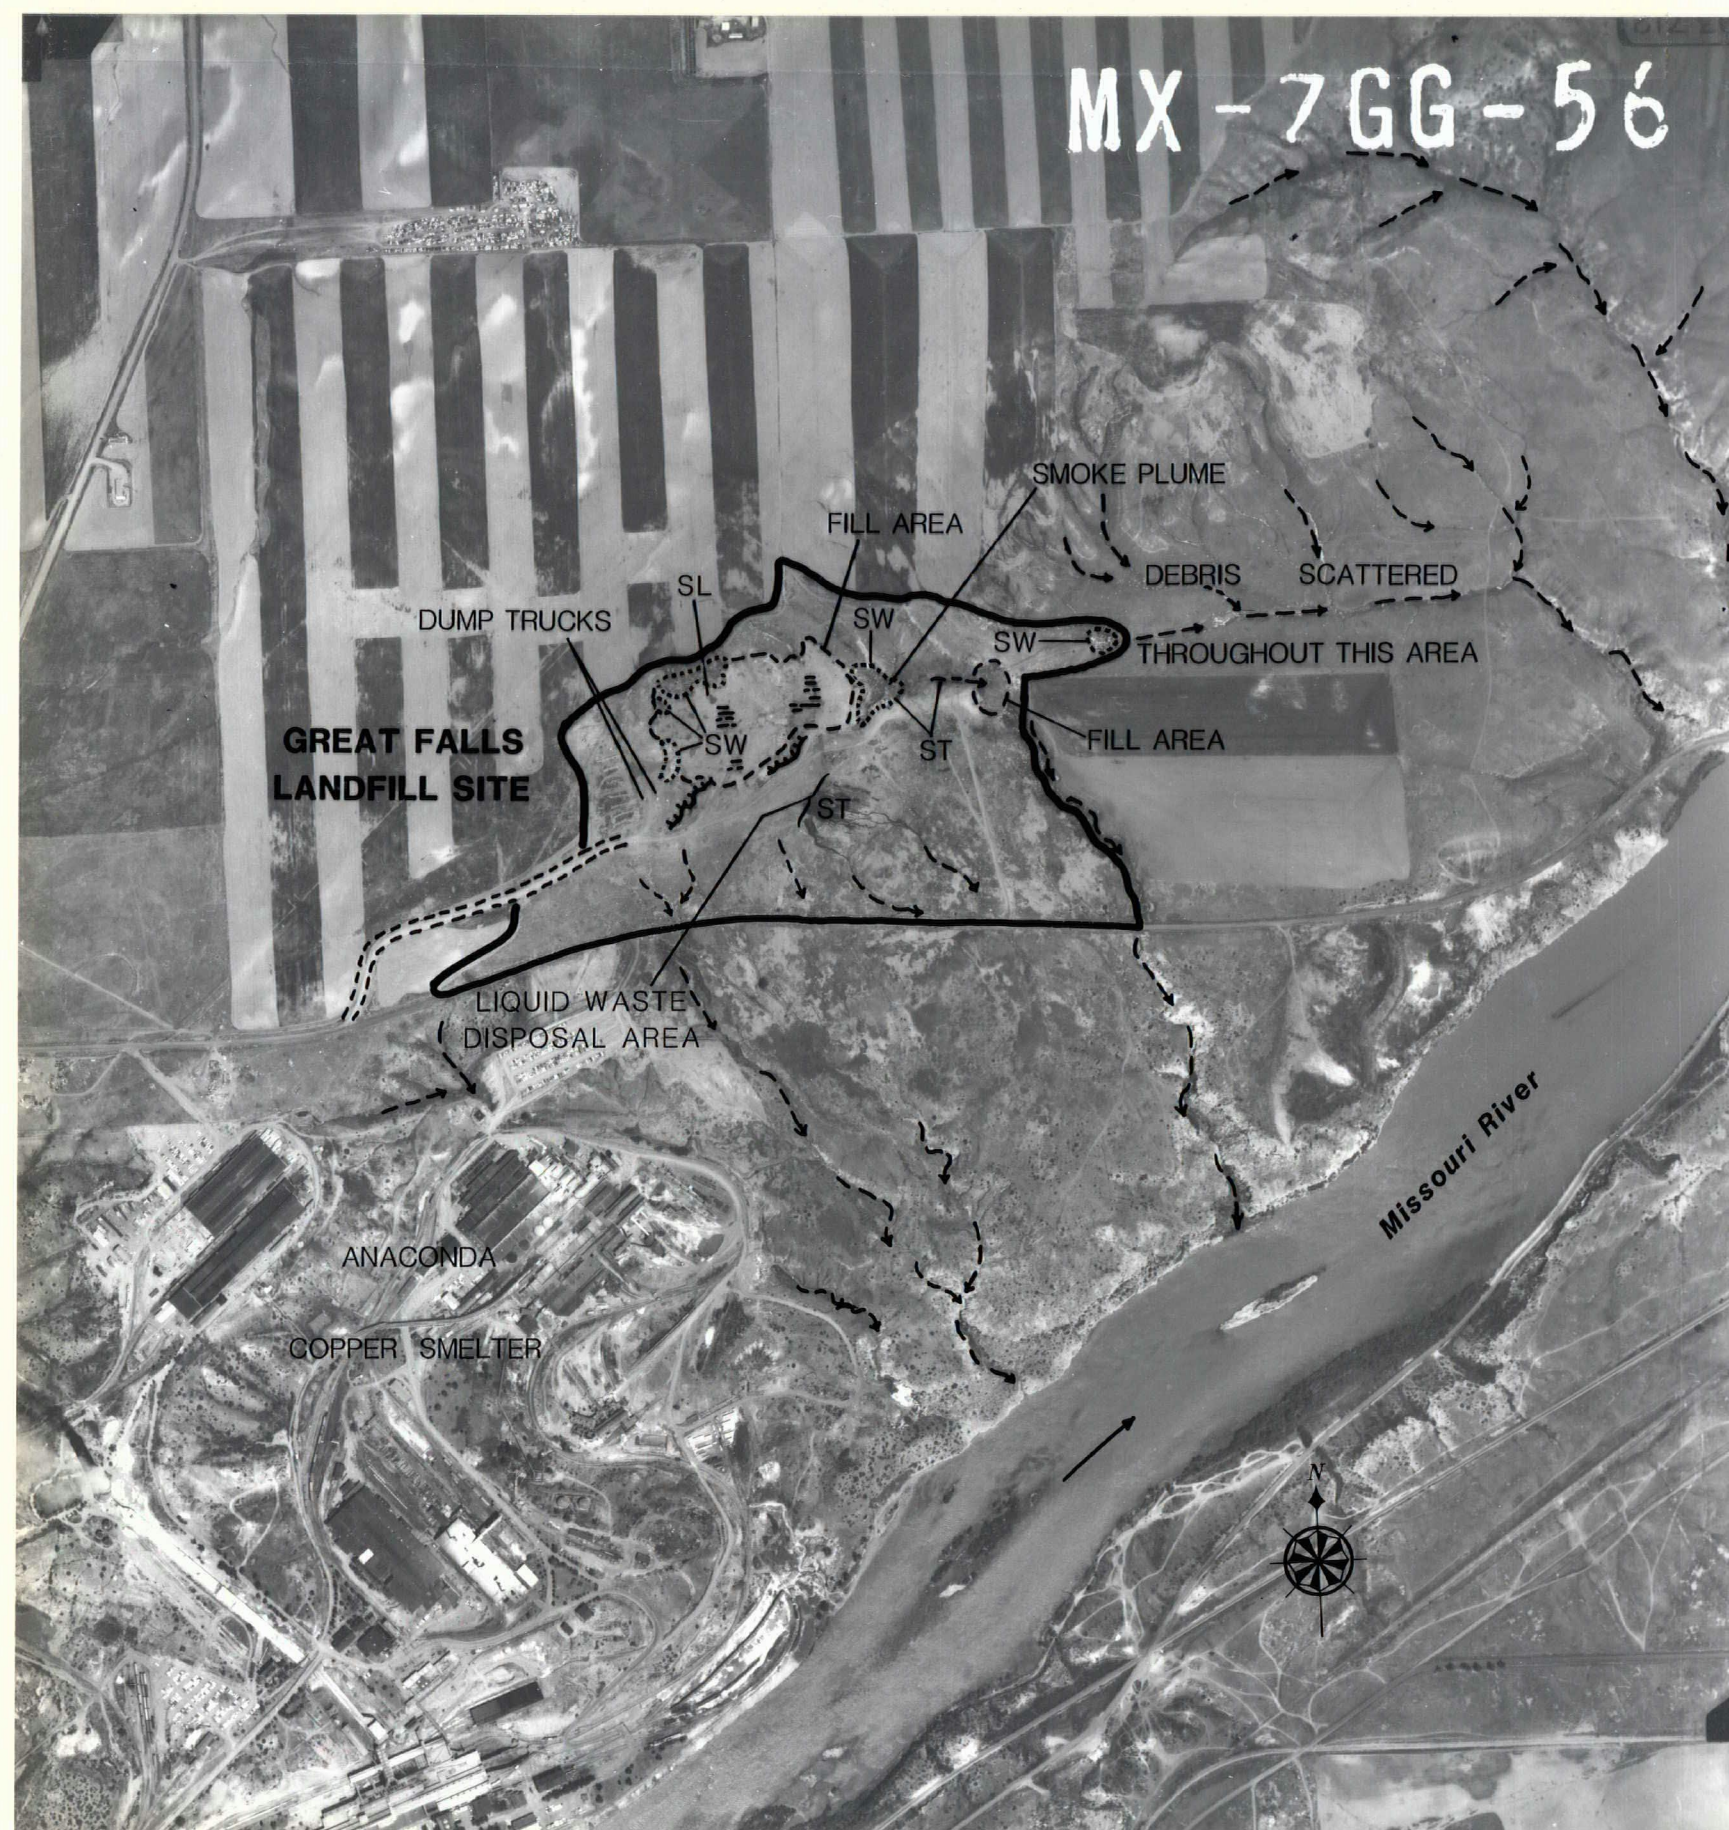
The 1966 photograph (Figure 18) shows that a large fill area is now present at the site. A second smaller fill area is also located near the eastern edge of the site. Small pools of standing liquid are present on the surface of the larger fill area. These pools could be accumulated precipitation or seepage from buried wastes. Solid waste is being deposited at five points within the site. Two of these areas are located in drainages. A smoke plume visible at one of these areas indicates that waste is being burned at this point. Staining at the liquid disposal area is heavier than in 1964. Some of the liquid stains reach to the local drainage pattern; however, it does not appear that any of the liquid has left the site. Staining is also visible at two other locations within the site. One of these is at a solid waste disposal area. Debris can be seen scattered through a drainage east of the site, this is probably refuse blown off the site.

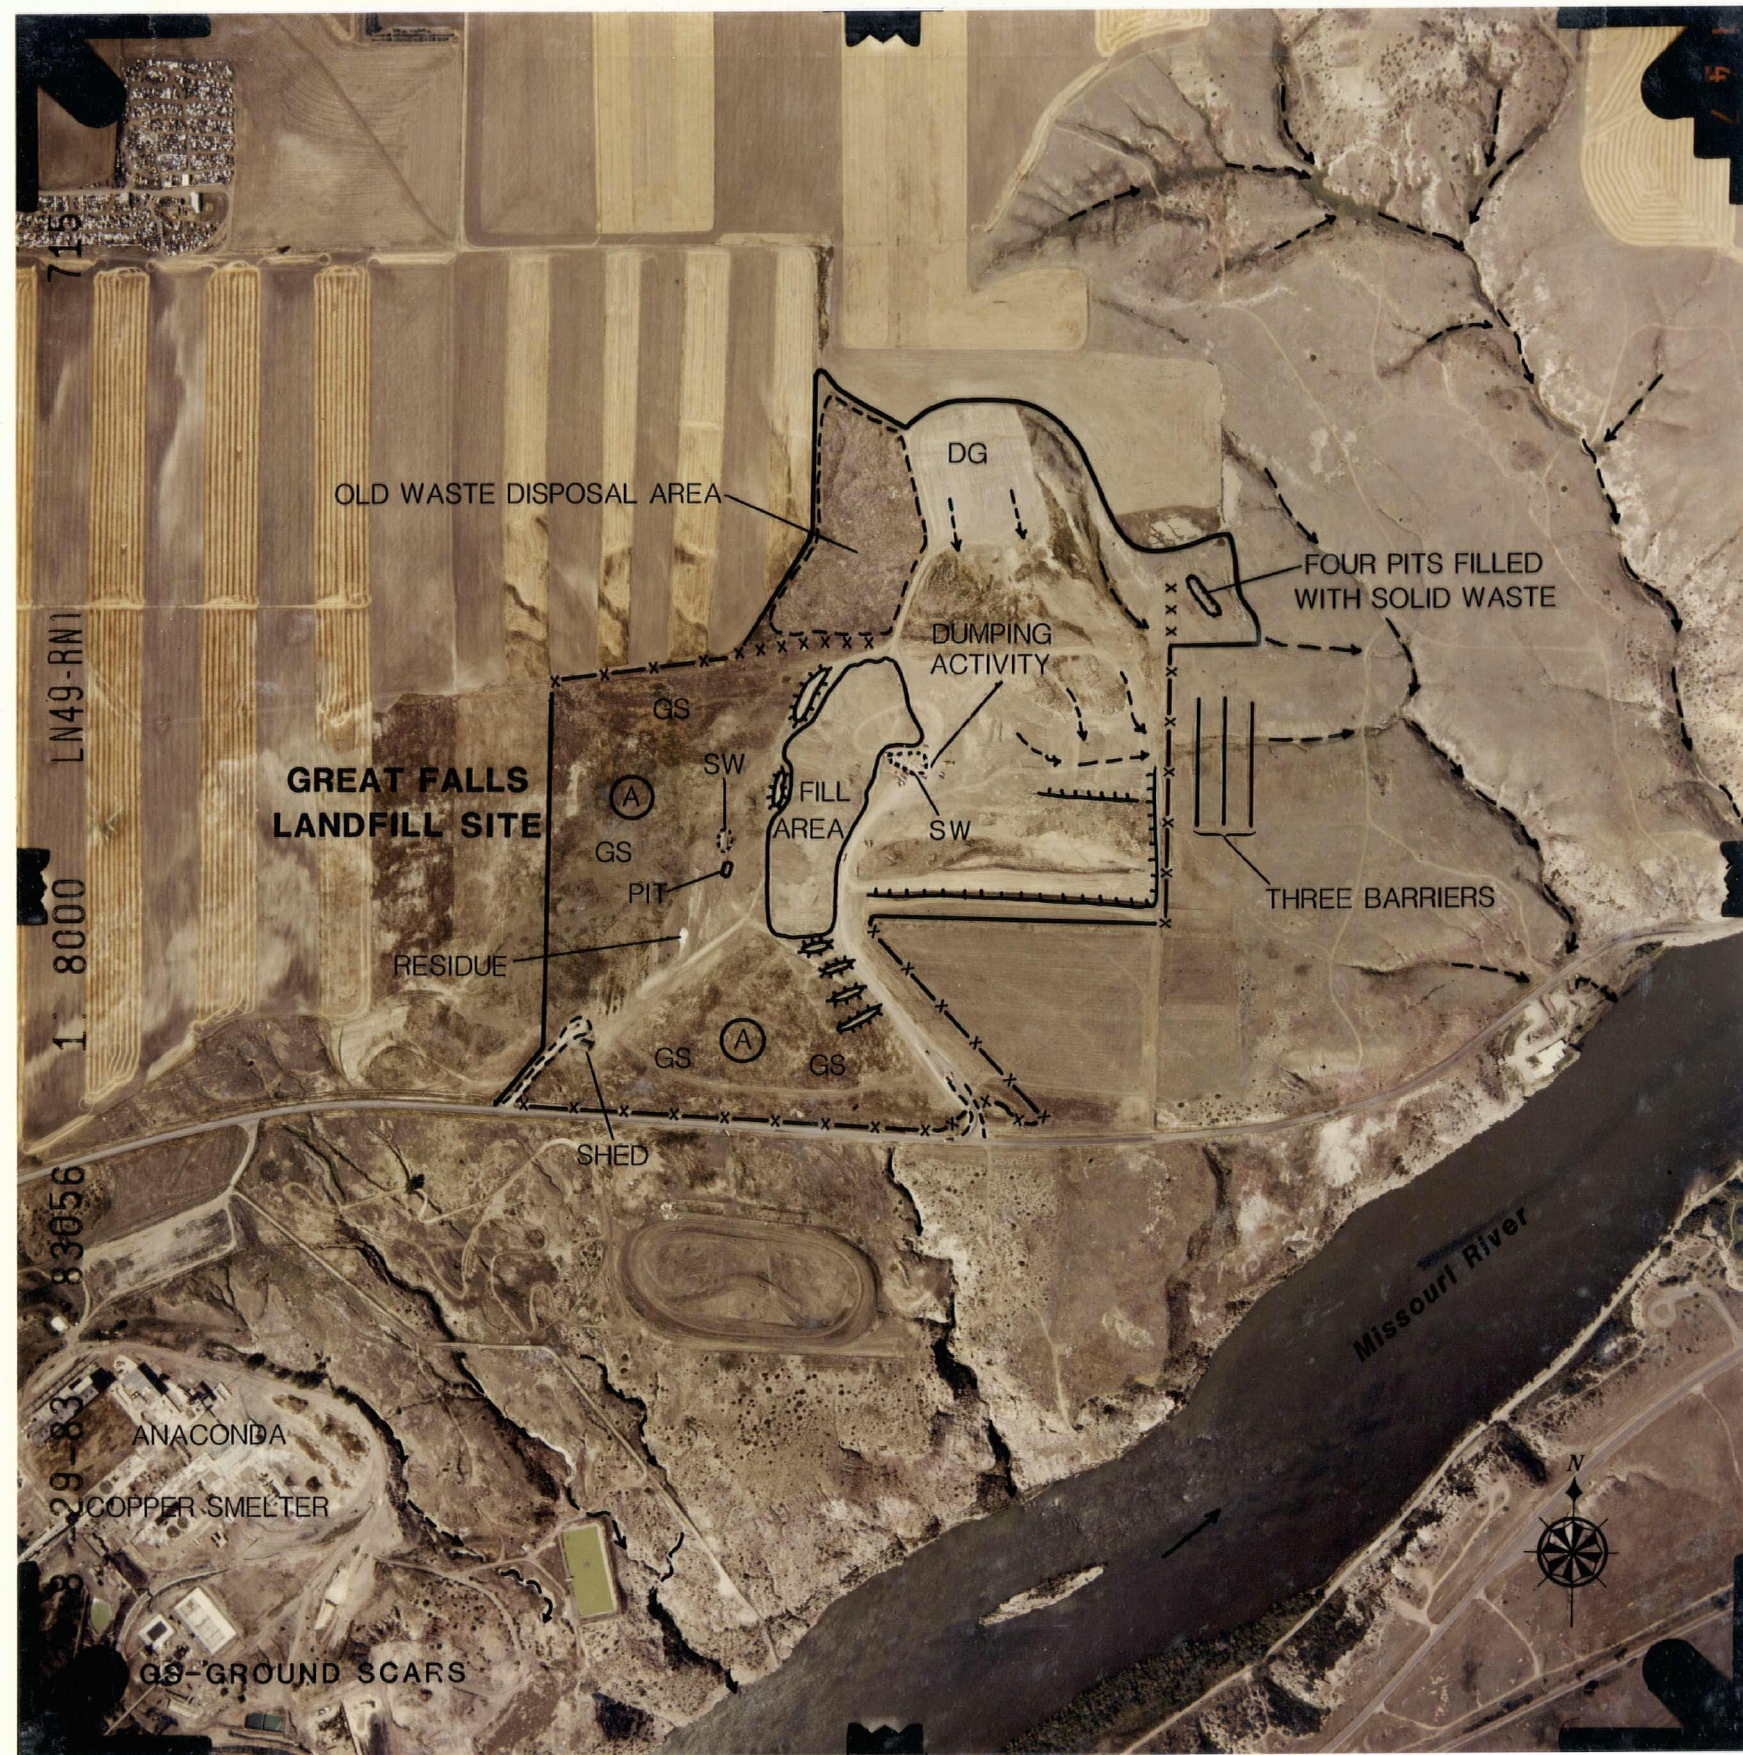
Figure 20. Great Falls Landfill site, August 29, 1983. Approximate scale 1:8,000.

The fill area located immediately west of this point has expanded significantly since 1977. Solid waste scattered over this area suggest that waste is being buried here. Four pits visible in the northeast corner of the site in 1977 have been filled with solid waste. A small concentration of waste is also located west of the fill area. A small pit is located nearby. These features are located in the same area where dumping and burial trenches were observed in 1977. A white residue is also present in this area.

Six mounds of earth can be seen both west and south of the fill area. These are probably stock piles for waste burial. In the northern section of the site a new area of bulldozed ground is visible. No solid waste is visible at this area. Landfill surfaces in the southwest section of the site are beginning to show signs of revegetation (Annotation "A"); however, the vegetation appears stressed and ground scarring is still present throughout these areas. No vegetation is visible on the old waste disposal area. The three barriers running across the wash east of the site are probably there to prevent debris from flowing or blowing off the site. No waste disposal is evident in the large excavations in the southeast section of the site.

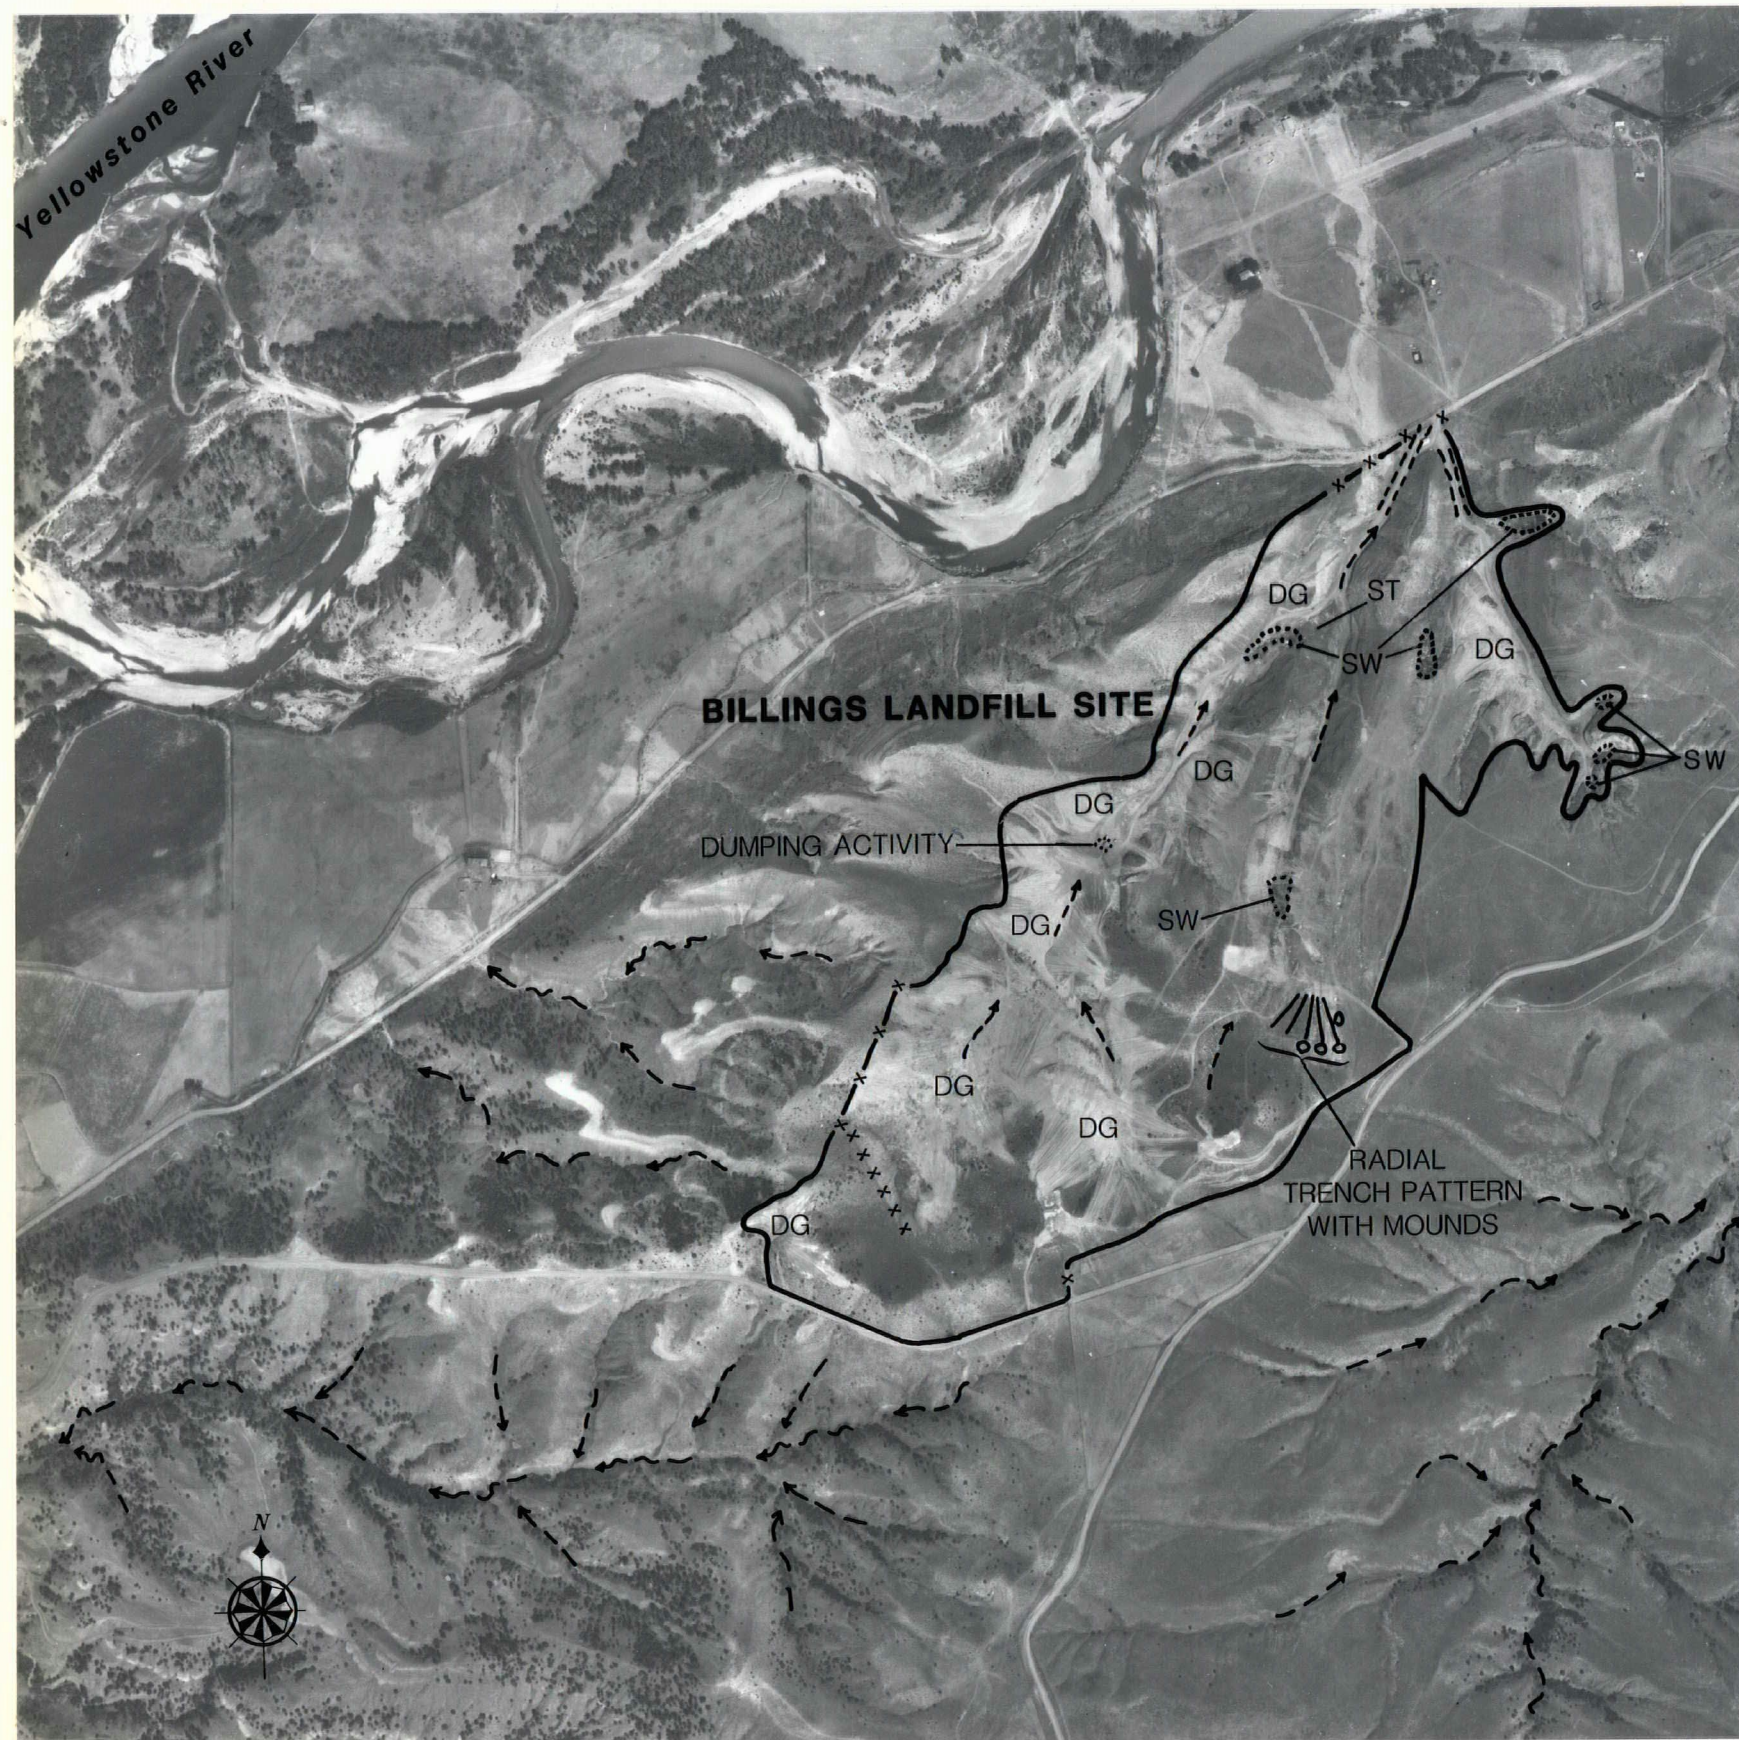
The 1966 photograph (Figure 23) shows that extensive waste disposal activity is underway at the site. Actual dumping activity is visible on the west central edge of the site; solid waste is visible at this and seven other locations within the site. No attempt to cover the waste has been made and waste disposal appears to be taking place in a random manner. Staining is associated with one of these areas. All of the disposal areas are located in drainages and contaminants from the waste could be carried off the site by runoff. Five narrow shallow trenches are arranged in a radial pattern in the southeast section of the site. Four mounds appear to be associated with these trenches and the ground around the trenches appears to be charred or stained. The nature of these trenches is not apparent. New fences run across the entrance to the site on the north and along two other sections on the south and west. Large areas of disturbed ground can be seen throughout the site.
